pitt&sherry

Rehabilitation Management Plan

Attunga Limestone Mine

8 August 2022

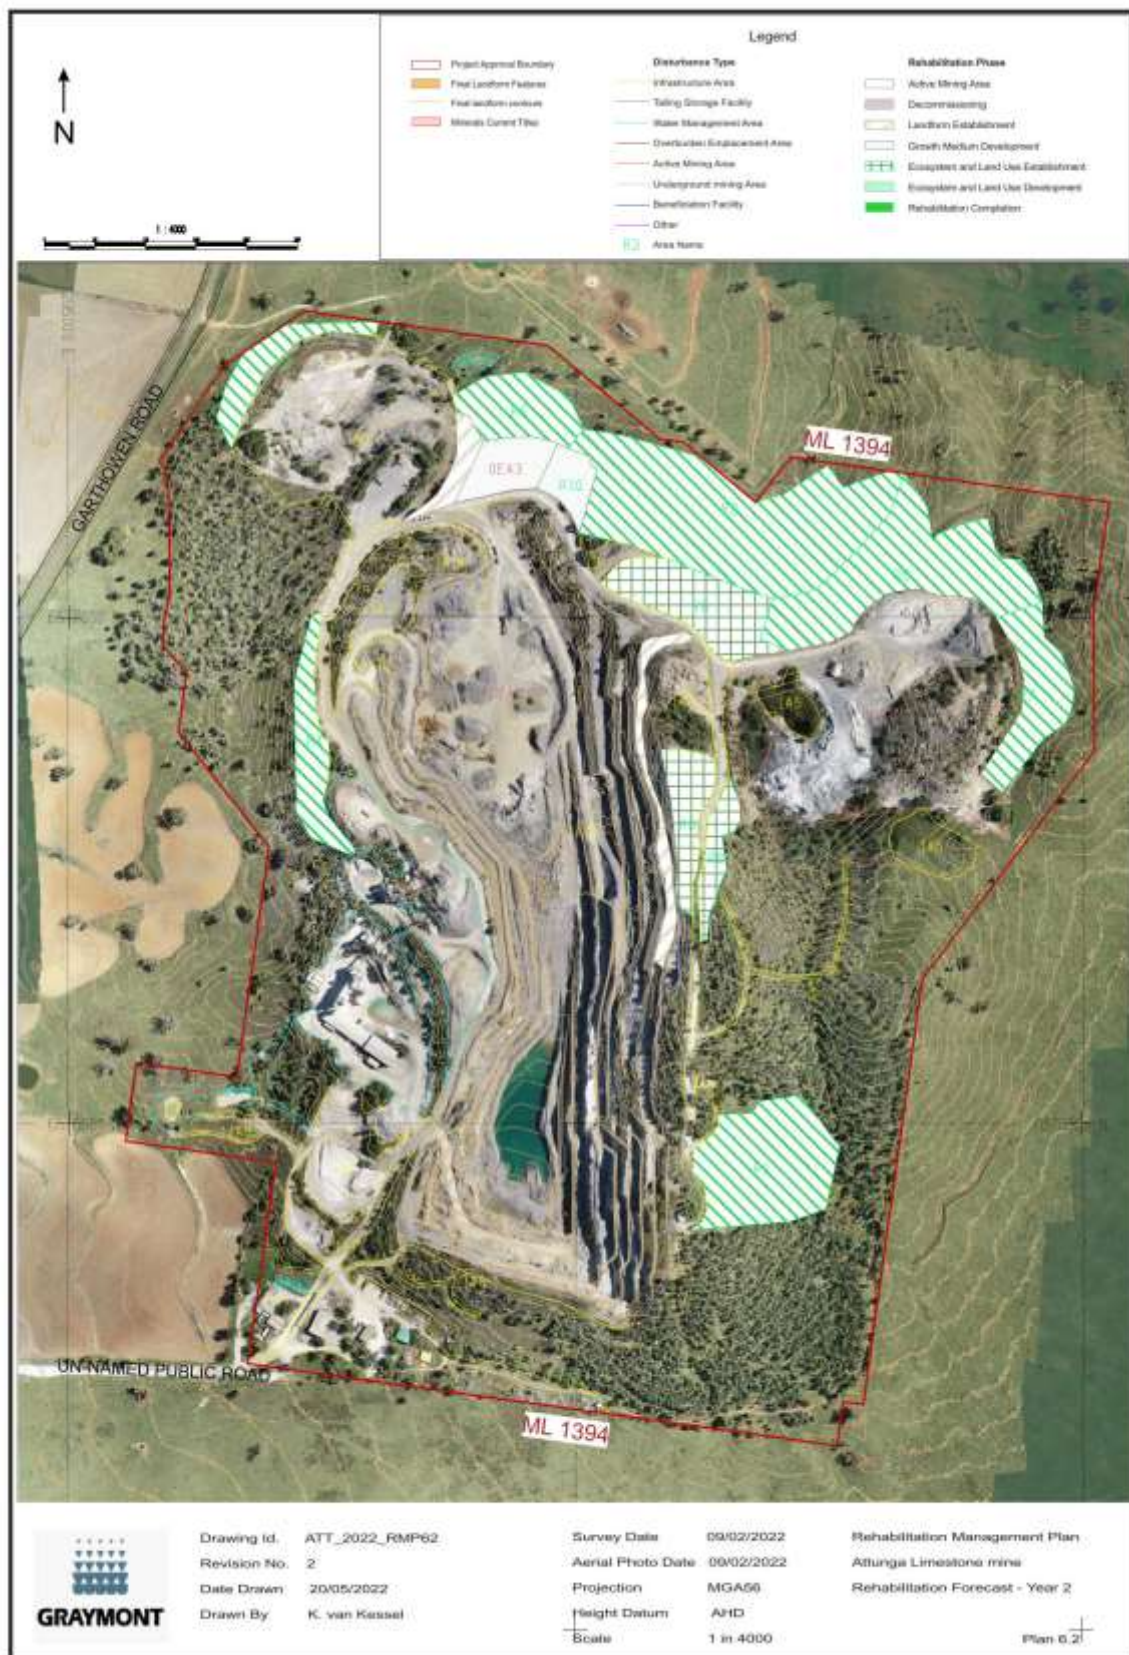
Figure 6 presents the rehabilitation phases for the year 2022. The summary of the key rehabilitation activities for 2022 is as follows:

- Overburden emplacement area from R1 to R9 will continue to be in the Ecosystem and Land Use Development rehabilitation phase
- Overburden emplacement area R10 will begin the Growth Media Development phase
- Overburden emplacement area OEA3, which is an extension of R10 is currently in the Decommissioning phase and will begin Landform Establishment phase, later this year
- A part of the Infrastructure disturbance area identified as IA3 will begin the Landform Establishment rehabilitation phase; and
- A final void section identified as AMA2 - 433 berm will begin the Landform Establishment phase.

Figure 6: Rehabilitation schedule year 2022

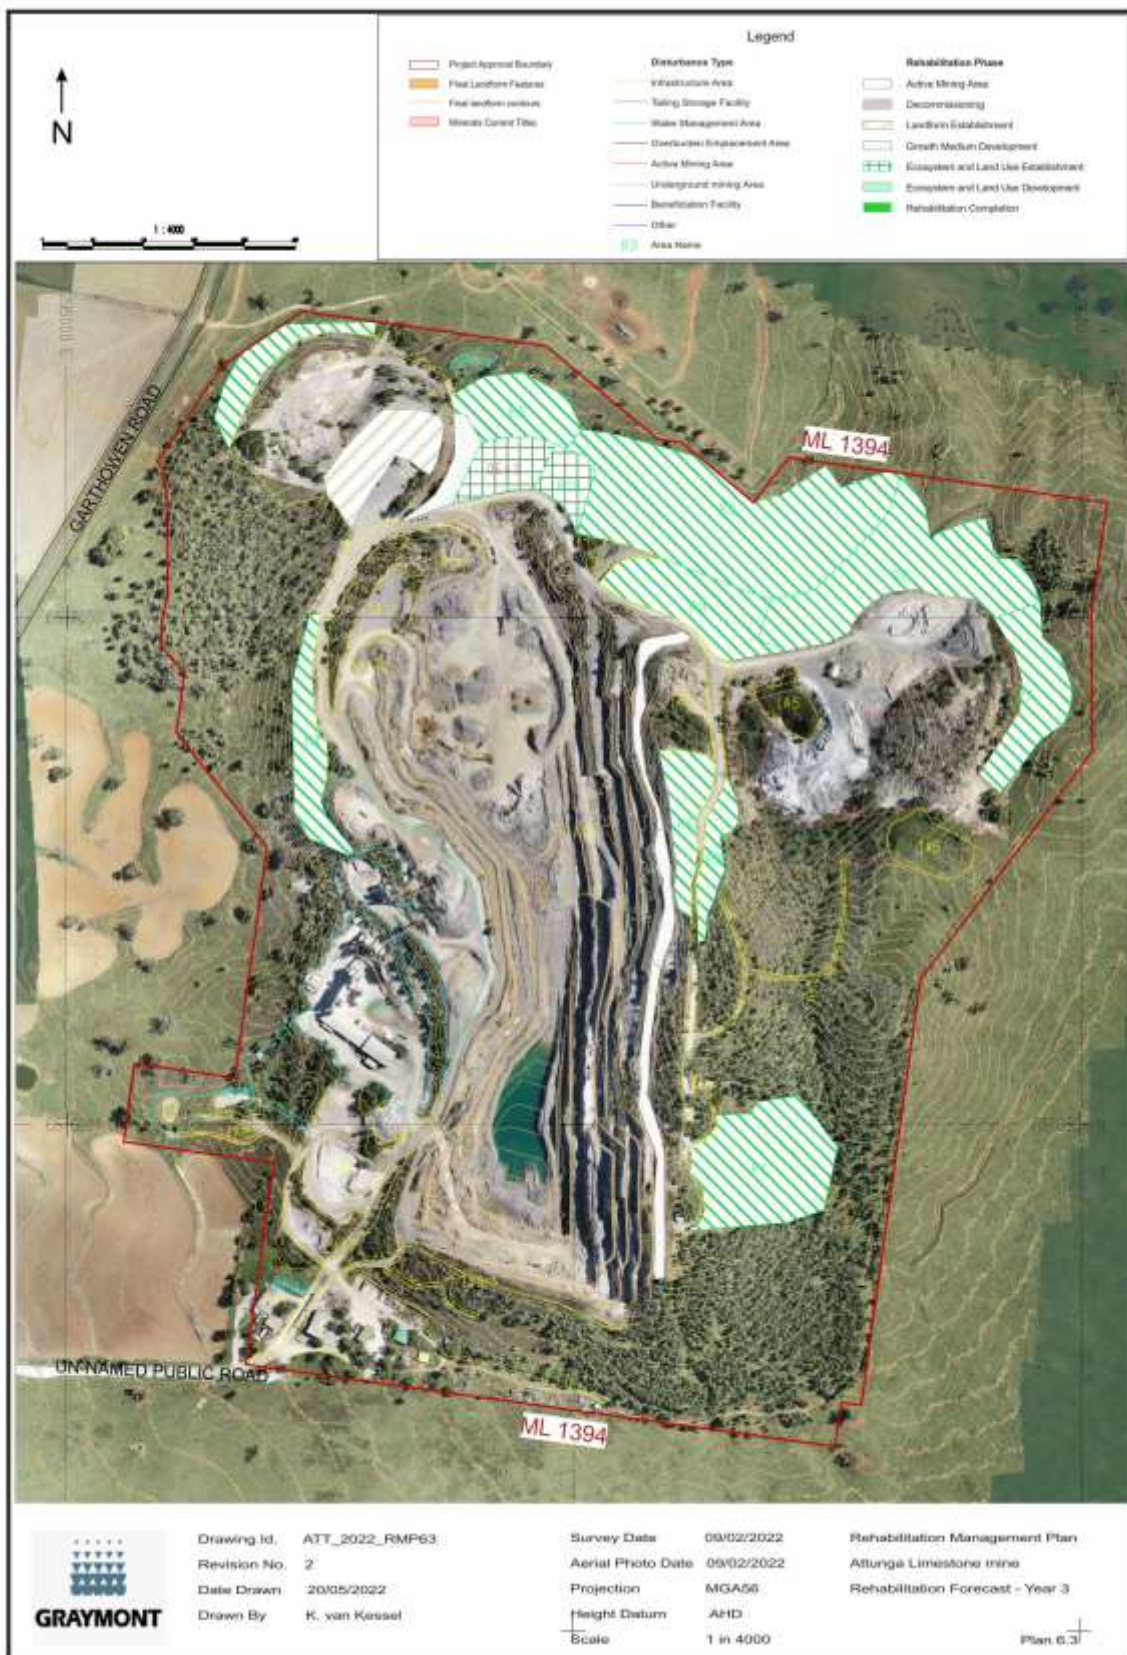
Figure 7 presents the rehabilitation phases for the year 2023. The summary of the proposed rehabilitation phases and activities for 2023 is as follows:

- A part of the infrastructure area identified as IA3 East will commence the Growth Medium Development phase while another section will begin with the Landform Establishment phase
- Overburden emplacement area from R1 to R9 will continue to be in the Ecosystem and Land Use Development rehabilitation phase
- Overburden emplacement area R10 will continue to be in the Growth Media Development phase
- Overburden emplacement area OEA3, which is an extension of R10, will continue to be in the Landform Establishment phase; and
- A section of the final void identified as AMA2 - 433 berm will continue to develop the Landform Establishment phase.

Figure 7: Rehabilitation schedule year 2023

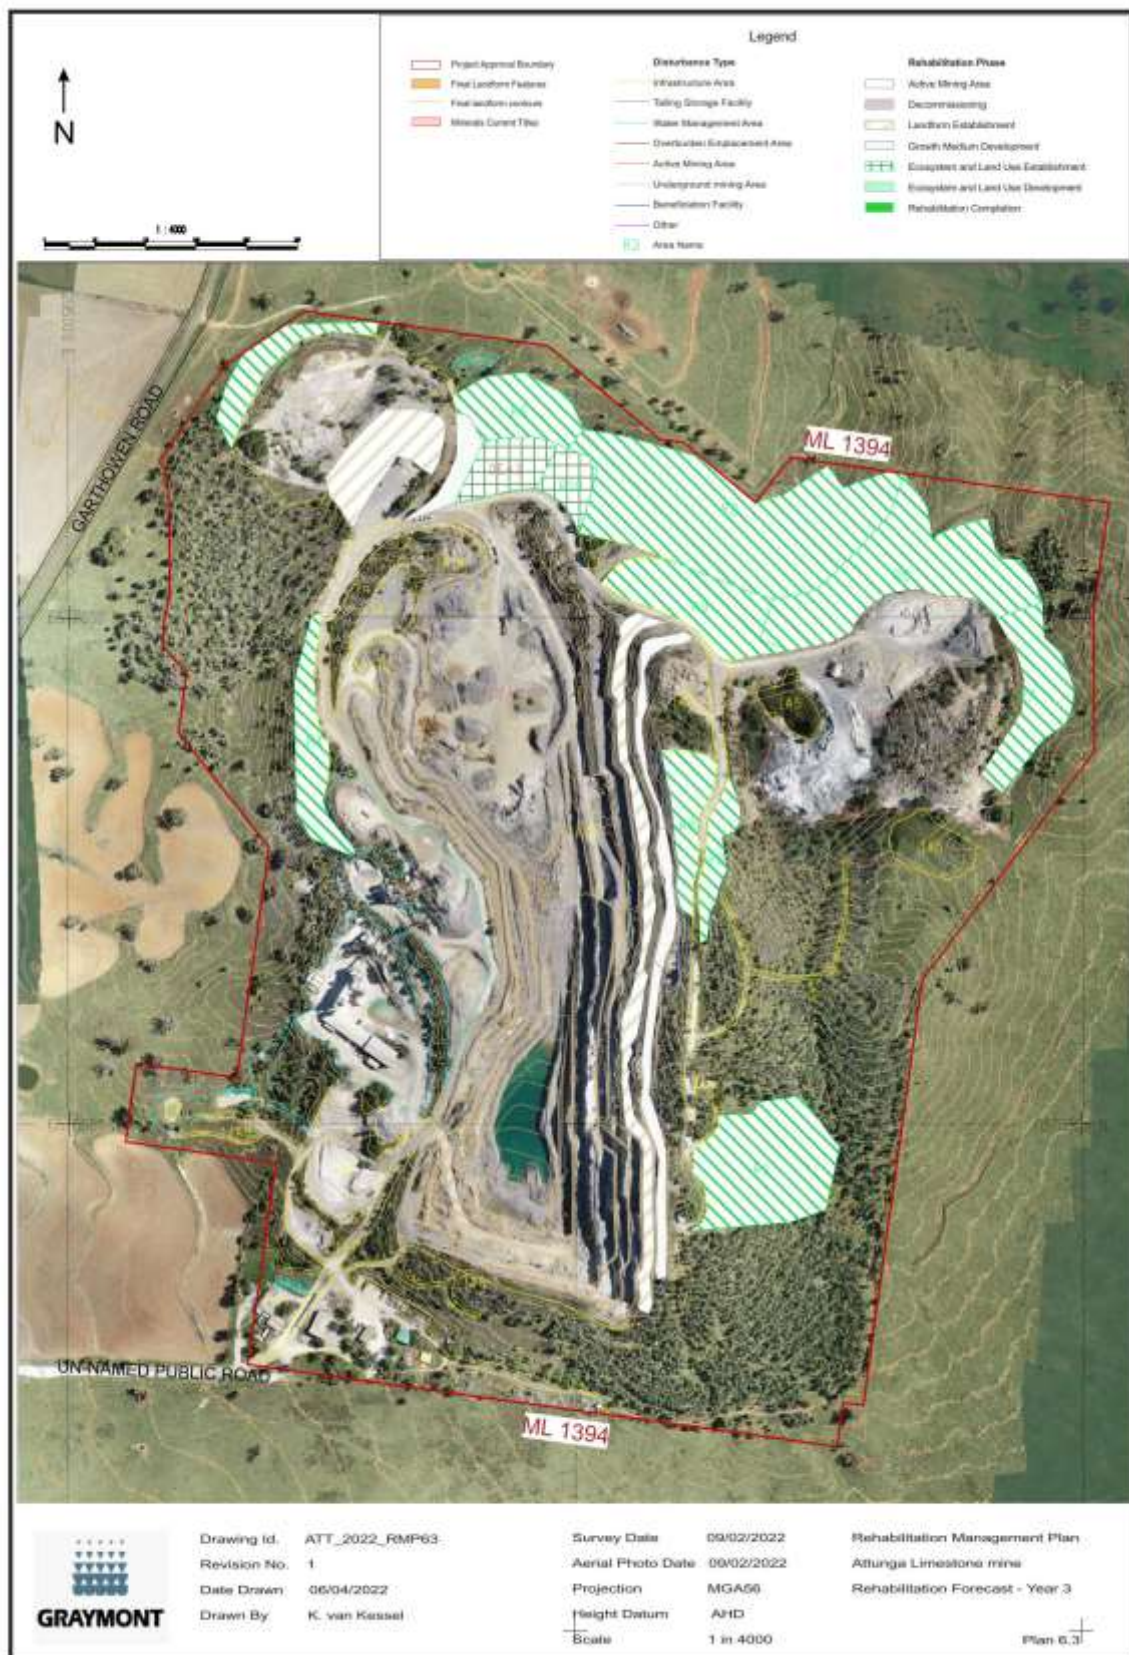
Figure 8 presents the rehabilitation phases for the year 2024. The summary of the proposed rehabilitation phases and activities for 2024 is as follows:

- During 2023 and 2024, stockpile/infrastructure area identified as IA3 East will begin the Landform Establishment and then will continue with the Growth Media Development phase
- The stockpile/infrastructure area identified as IA3 Top bench will comment the Landform Establishment phase in 2024
- Overburden emplacement area from R1 to R9 will continue to be in the Ecosystem and Land Use Development rehabilitation phase
- By the end of 2024, the Overburden emplacement area R10 will be in the Ecosystem and Land Use Establishment phase
- Overburden emplacement area OEA3 will also transition to the Ecosystem and Land Use Establishment phase in 2024
- In 2024, the final void identified as AMA2 – 433 berm will begin the Growth Media Development phase; and
- The final void identified as AMA2 – 422 berm will begin the Landform Establishment phase in 2024.

Figure 8: Rehabilitation schedule year 2024

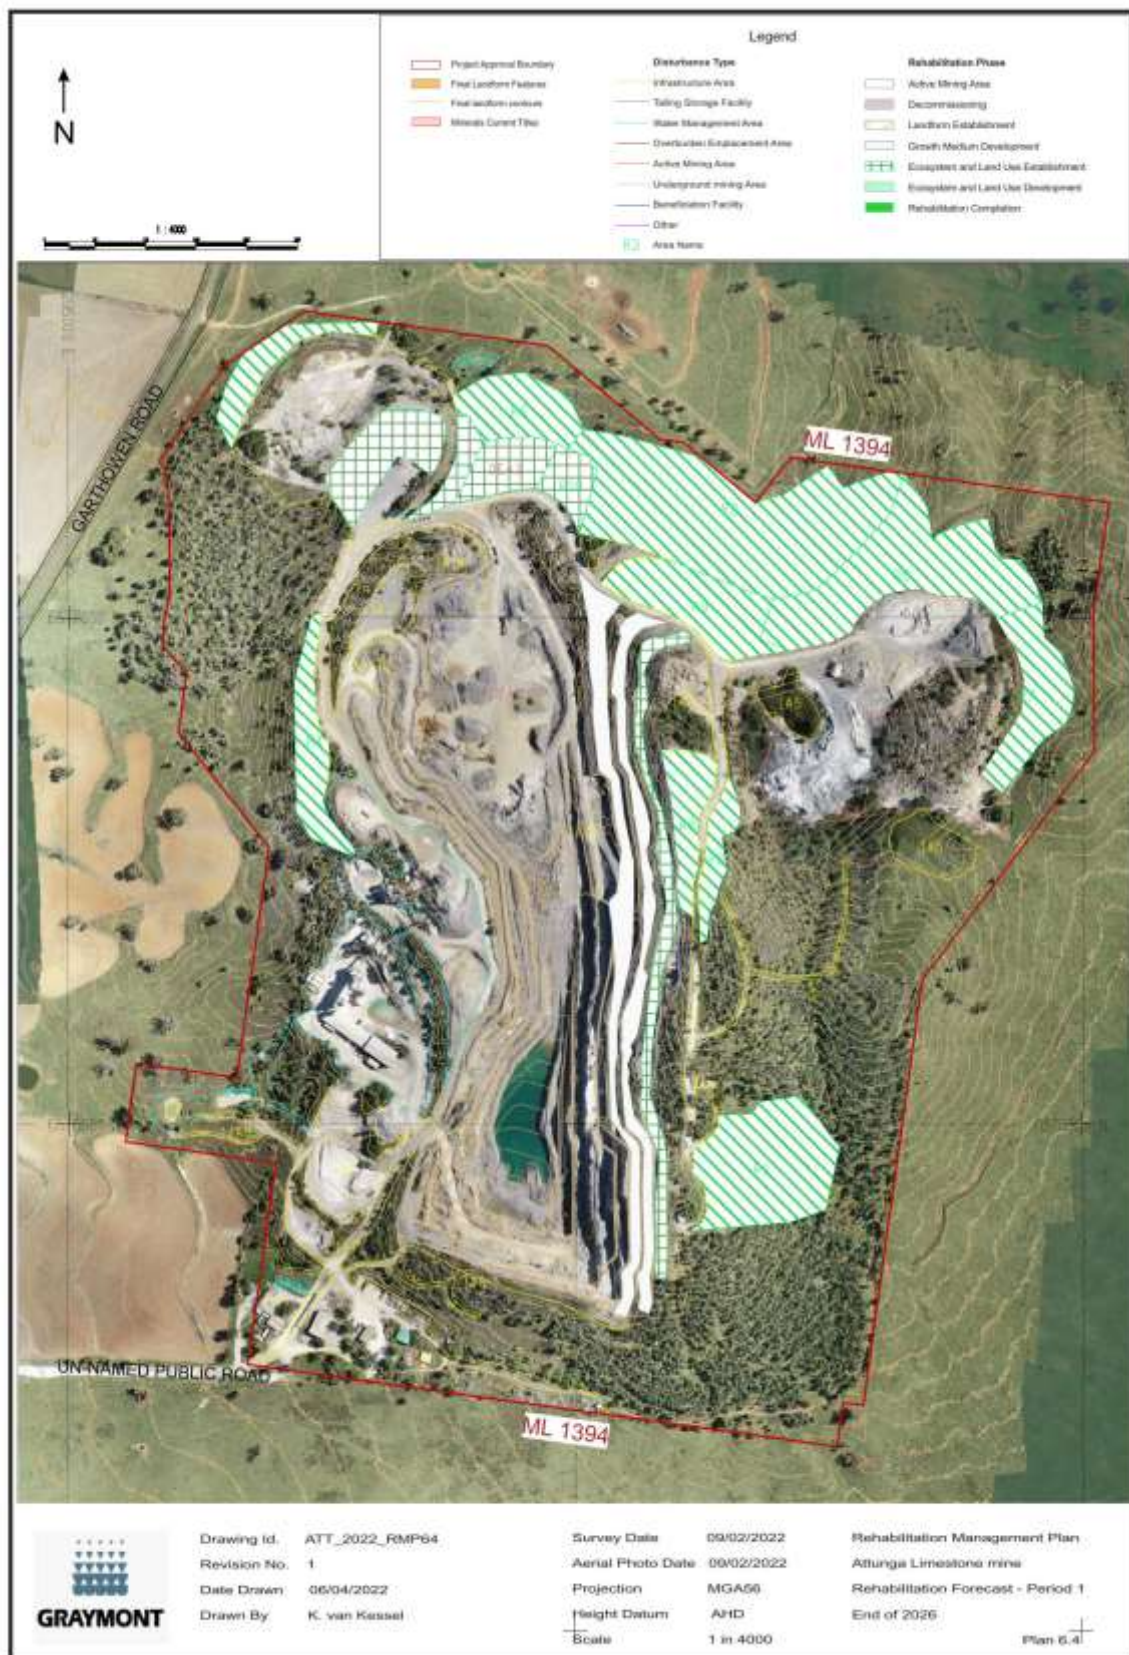
Figure 9 presents the rehabilitation phases to be completed by the end of the year 2026. The summary of the proposed rehabilitation phases and activities is as follows:

- Stockpile/infrastructure area identified as IA3 East and IA3 Top bench will be in the Ecosystem and Land Use Establishment phase
- Overburden emplacement area from R1 to R10 and OEA3 will continue to be in the Ecosystem and Land Use Development rehabilitation phase
- The final void area identified as AMA2 – 433 berm will be the in Ecosystem and Land Use Establishment phase; and
- The final void area identified as AMA2 – 422 berm and AMA2 – 411 East berm -411 level will be in the Growth Media Development phase.

Figure 9: Rehabilitation schedule year 2026

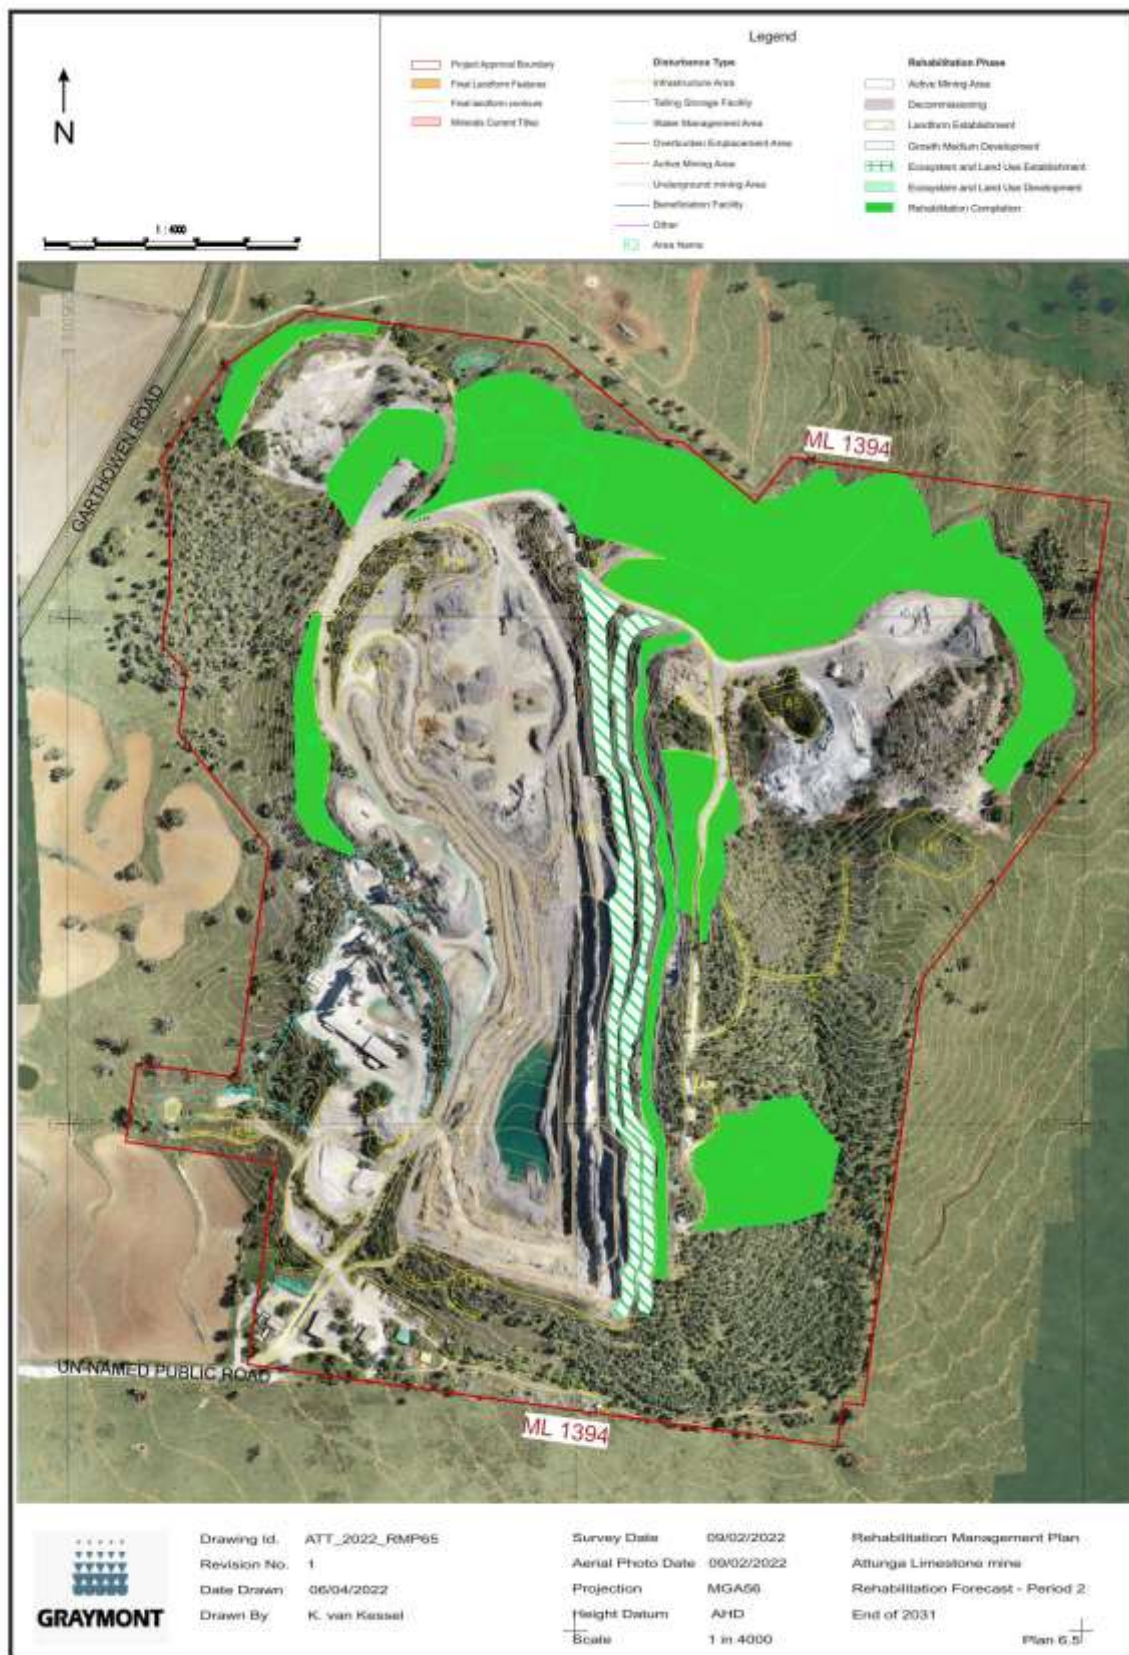
Figure 10 presents the rehabilitation schedule to be completed by the end of the year 2031. The summary of the proposed rehabilitation phases and activities is as follows:

- Stockpile/infrastructure area identified as IA3 East and IA3 Top bench will be completely rehabilitated
- Overburden emplacement area from R1 to R10 and OEA3 will be completely rehabilitated
- The final void area identified as AMA2 – 433 berm will be completely rehabilitated; and
- The final void area identified as AMA2 – 422 berm and AMA2 – 411 East berm-411 level will be in the Ecosystem and Land Use Development phase.

Figure 10: Rehabilitation schedule year 2031

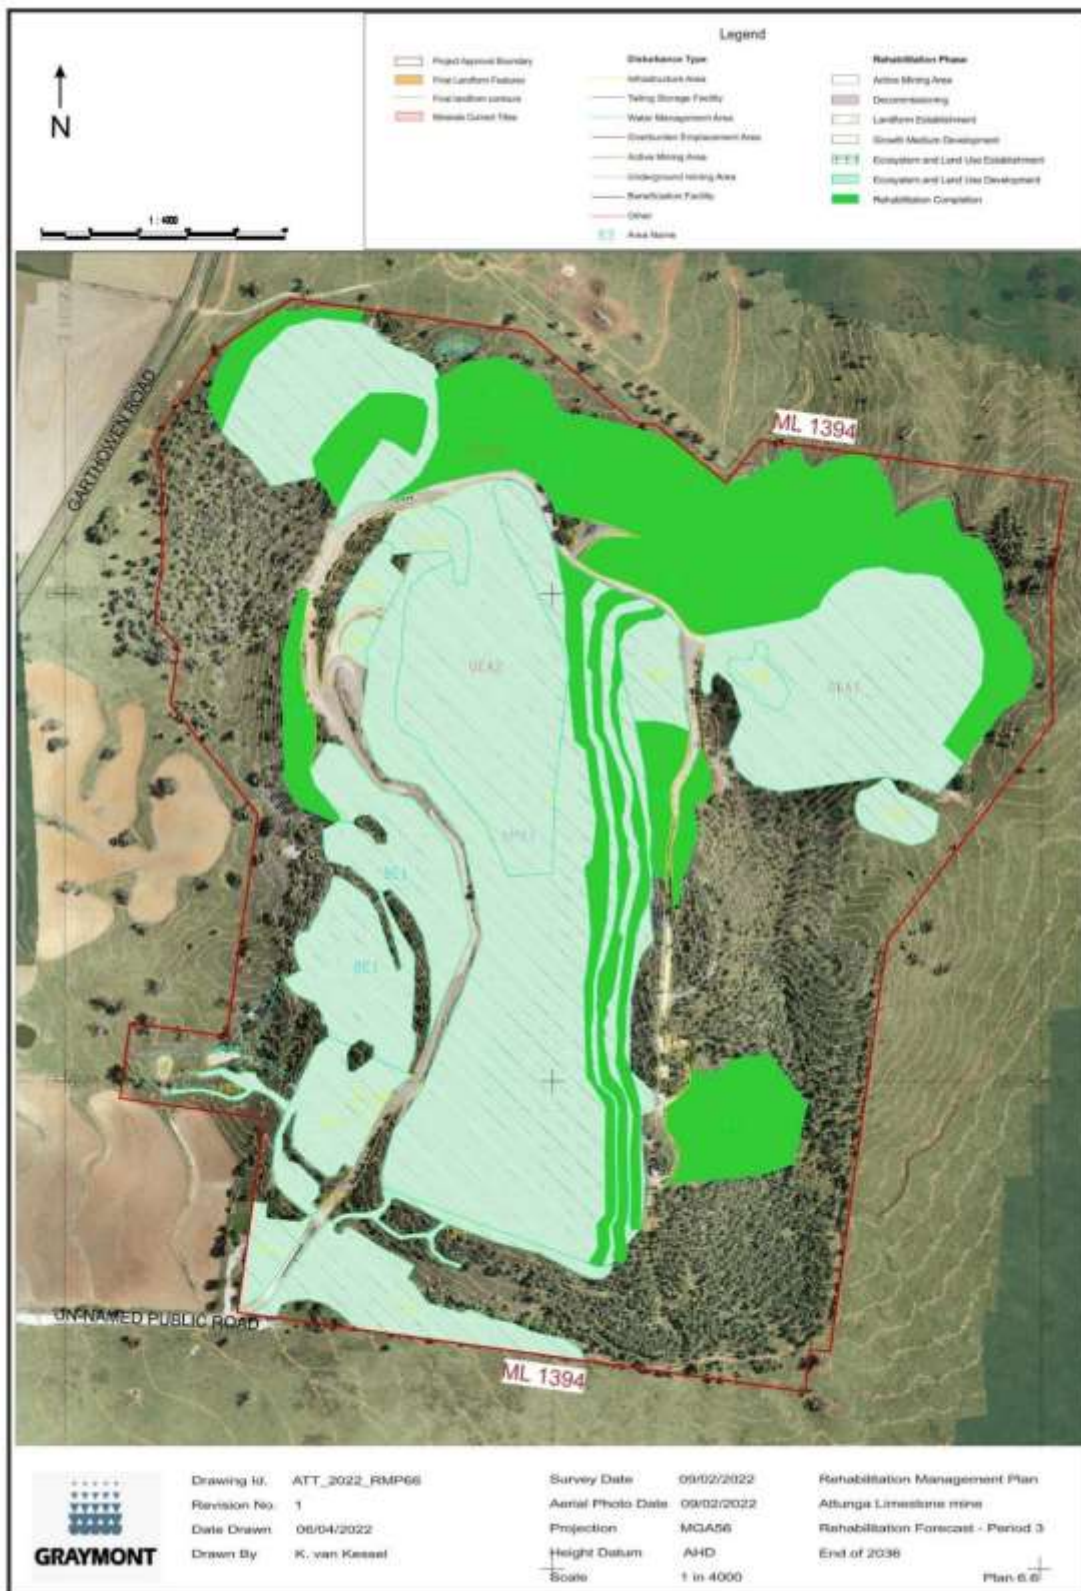
Figure 11 presents the rehabilitation schedule to be completed by the end of the year 2036. A summary of the proposed rehabilitation phases and activities is as follows:

- Overburden emplacement areas identified as OEA3 and OEA4 will be completely rehabilitated
- The final void area identified as AMA1 Jackson open pit West and AMA2 Jackson open pit – East will be in the Ecosystem and Land Use Development phase; and

- The final void area identified as AMA2 – 433 berm, AMA2 – 422 berm and AMA2 – 41 will be completely rehabilitated.

Figure 11: Rehabilitation schedule year 2036

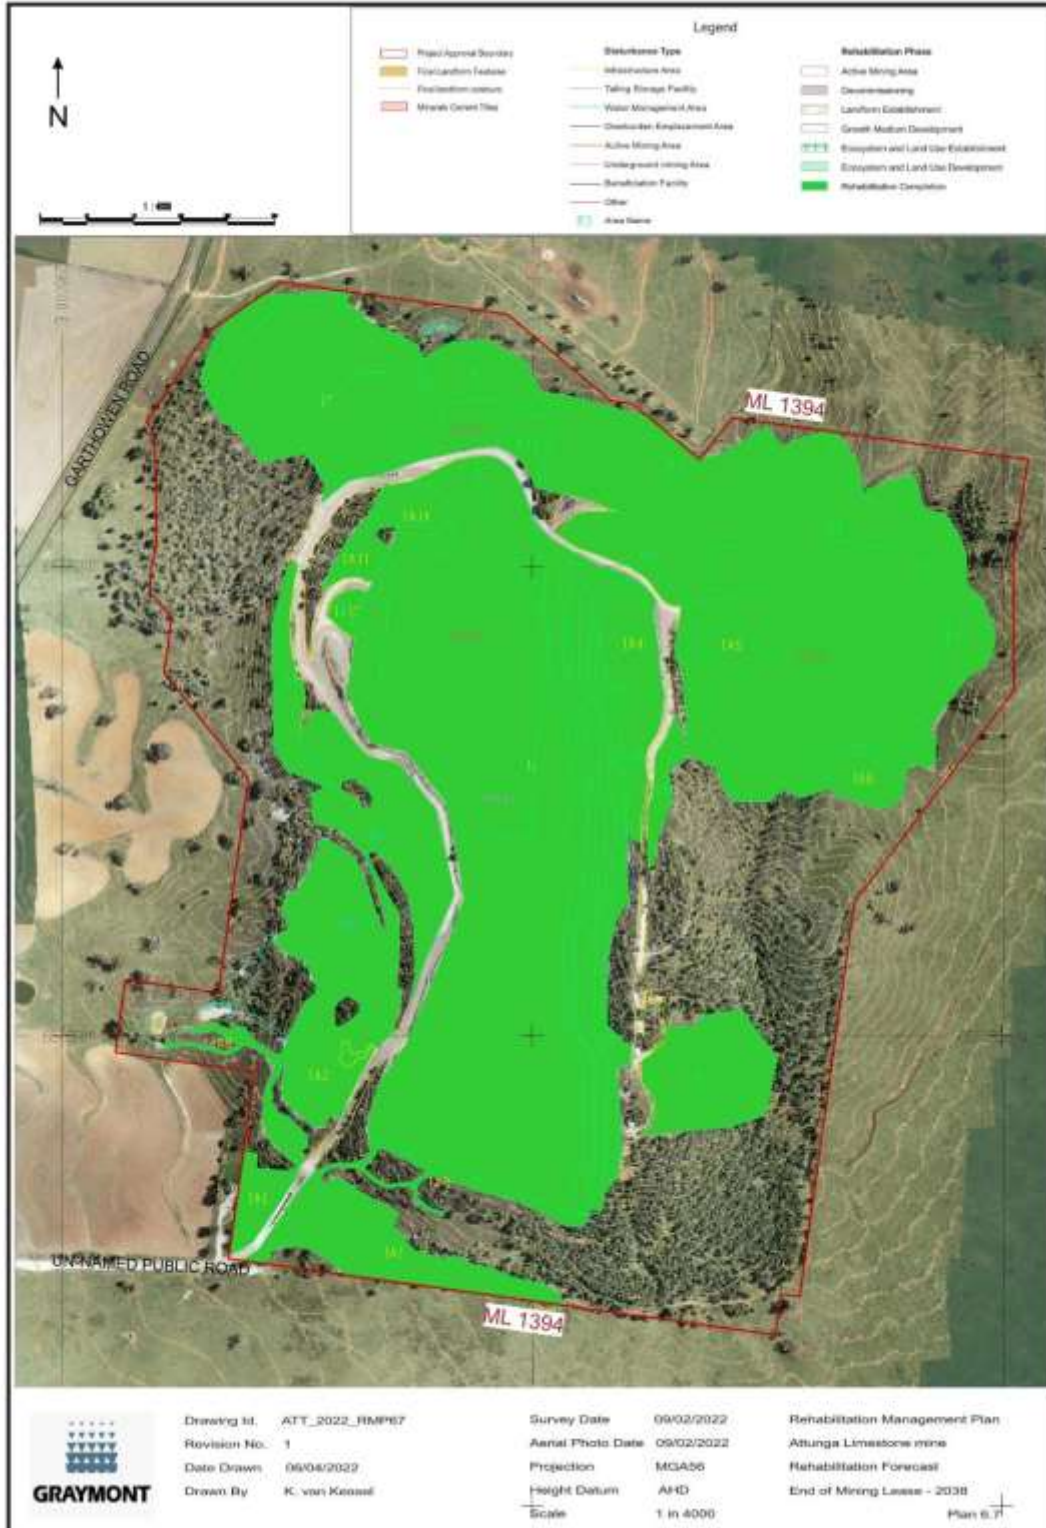
Figure 12 presents the rehabilitation schedule to be completed by the end of the year 2038. All disturbed areas are expected to be completed rehabilitated by the end of the mining lease.

Figure 12: Rehabilitation schedule year 2038

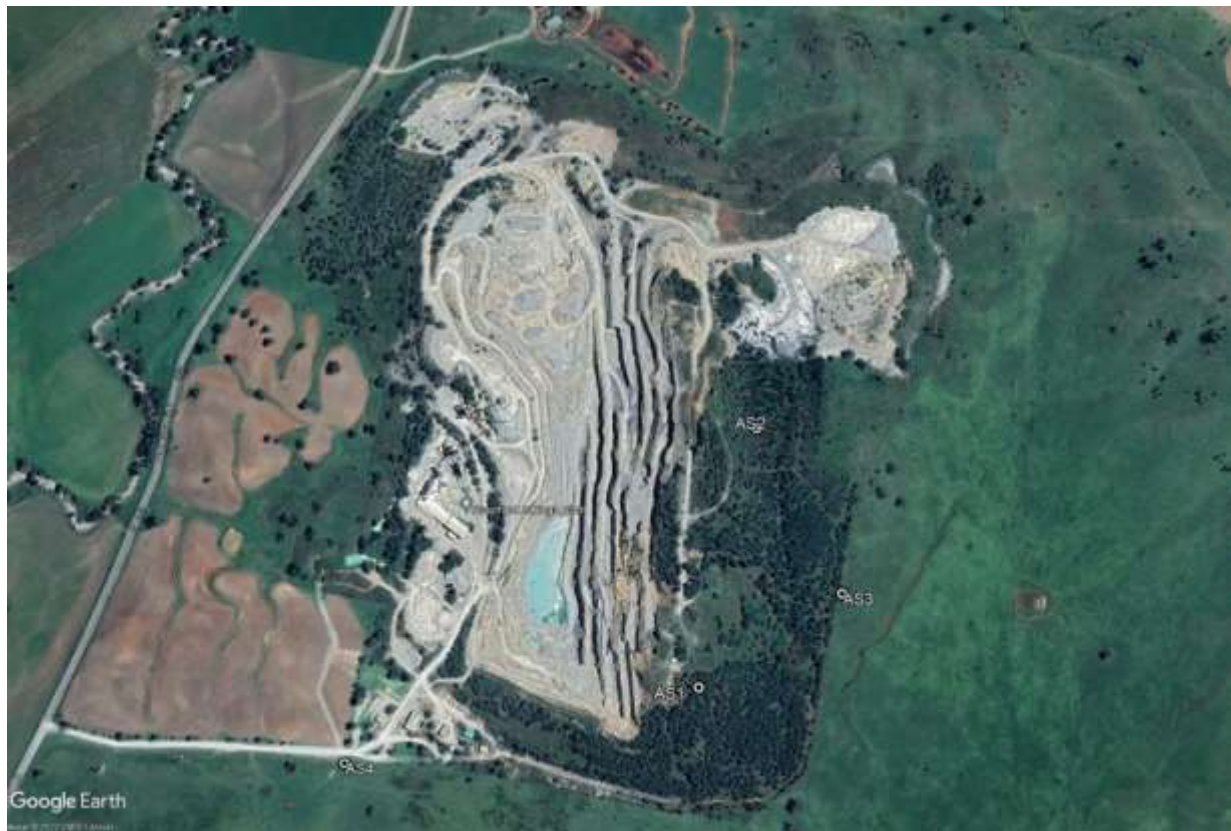
Figure 13 shows the four analogue sites.

Figure 13: Analogue sites

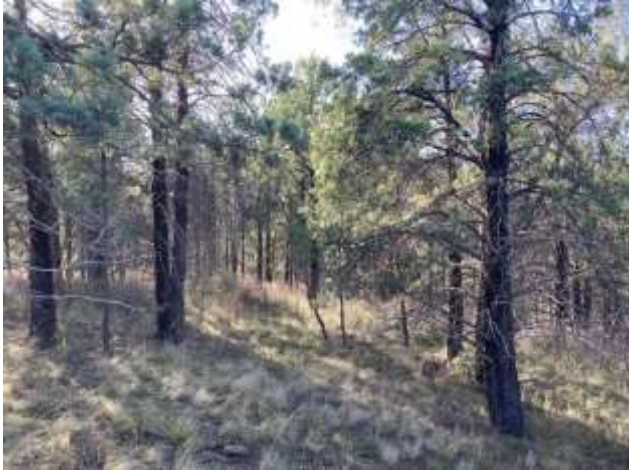
Table 17: Analogue site 1

Coordinates	30.92842° S, 150.86116° E
Ecosystem Type	Black Cypress Pine Forest.
Canopy / Emergent	Canopy is dominated with Black Cypress Pine (<i>Callitris endlicheri</i>) and wattle tress (<i>Acacia pycnantha</i>) by approximately 90% and 10%, respectively.
Shrub / Understory Layer	Primarily introduced species such as milkweed, dandelions, verain, horehound and common nightshade. These species are common weed species in the region and should be controlled.
Ground / Herb Layer	90% groundcover dominated by tussock grasses. There is also minor gravel and other herbaceous plants.
Fallen timber (Coarse woody debris)	Very low – Occasional thin (5-10mm diameter) sticks and rare medium (10-50mm diameter) sticks.
Landform	Moderately inclined upper slopes with a gradient of approximately 20%.
Soil Conditions	No visible erosion on site. A soil survey was no undertaken for this analogue site.

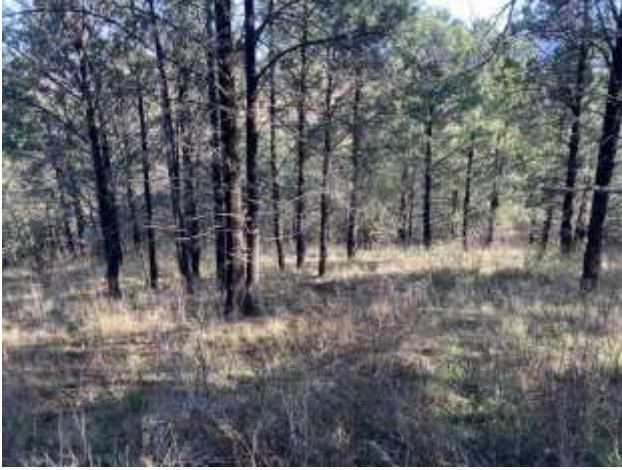
Table 18: Analogue site 2

Coordinates	<p>30.92647° S, 150.86193° E</p>
Ecosystem Type	<p>Black Cypress Pine Forest.</p>
Canopy / Emergent	<p>Canopy cover is around 60 to 70%, dominated by Black Cypress (<i>Callitris endlicheri</i>), White Box (<i>Eucalyptus albens</i>), and Wattle (<i>Acacia pycnantha</i>) tress.</p>
Shrub / Understory Layer	<p>Primarily introduced species such as milkweed, dandelions, verain, horehound, captuces, common nightshade, among others. These species are part of the native ecosystem of the region; however, they need to be controlled.</p>
Ground / Herb Layer	<p>95% groundcover dominated by tussock grasses. There is also moss and other type of herbaceous plants. This site has a rockier ground than analogue site 1.</p>
Fallen timber (Coarse woody debris)	<p>Small, medium, and large sticks, with some large logs and fallen branches.</p>
Landform	<p>Moderately inclined to steep upper slopes with a gradient of approximately 25 to 30%.</p>

Soil Conditions	<p>No visible erosion on site. A soil survey was no undertaken for this analogue site.</p>

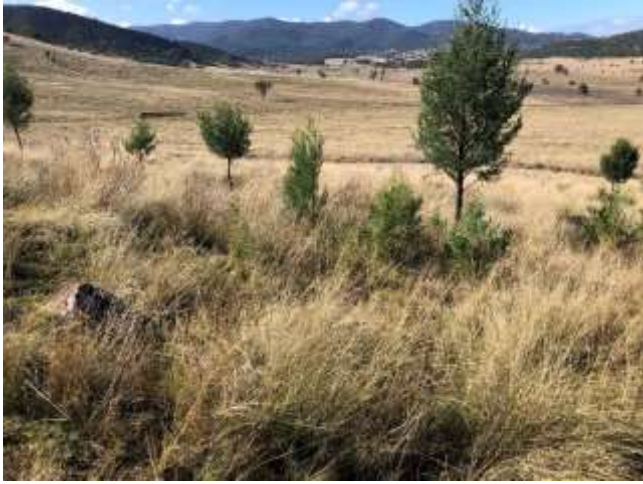
Table 19: Analogue site 3

Coordinates	30.92736° S, 150.86317° E
Ecosystem Type	Grazing woodland
Canopy / Emergent	Canopy cover is around 20% dominated by Black Cypress (<i>Callitris endlicheri</i>) which seems to be returning to this site.
Shrub / Understory Layer	A mixed pasture of native and introduced species.
Ground / Herb Layer	100% groundcover dominated by tussock grasses. Rocky cover less than 5%.
Fallen timber (Coarse woody debris)	None visible at the time of inspection.
Landform	Lower slope with a gradient of approximately 10 to 15%
Soil Conditions	No visible erosion on site. A soil survey was no undertaken for this analogue site.

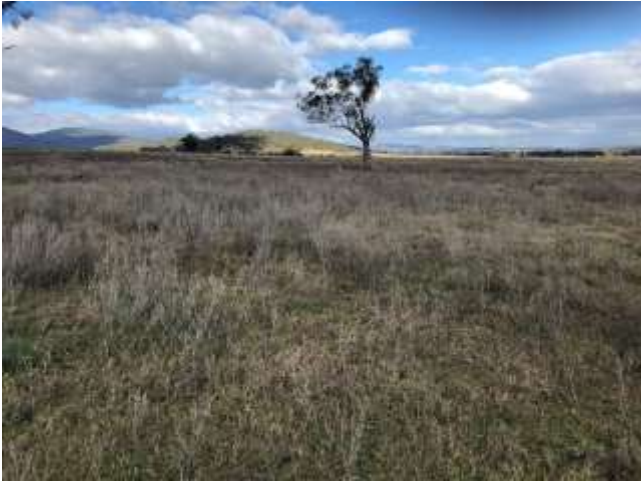
Table 20: Analogue site 4

Table 20 shows a selected analogue site for agricultural – grazing final land use. This site is located outside the project boundary at the south-west direction.

Coordinates	30.92951 S, 150.856040 E
Ecosystem Type	Grazed pasture/Grassland
Canopy / Emergent	Canopy cover is around 5-10% dominated by Eucalyptus trees.
Shrub / Understory Layer	A mixed pasture of native and introduced species.
Ground / Herb Layer	100% groundcover dominated by tussock grasses and foreign species including onion weed. Rocky cover less than 5%.
Fallen timber (Coarse woody debris)	None visible at the time of inspection.
Landform	Mid slope with a gradient of approximately 3%
Soil Conditions	No visible erosion on site. A soil survey was no undertaken for this analogue site.
