Rehabilitation Management Plan (RMP)

Galong Limestone Mine

Date
8 February 2024

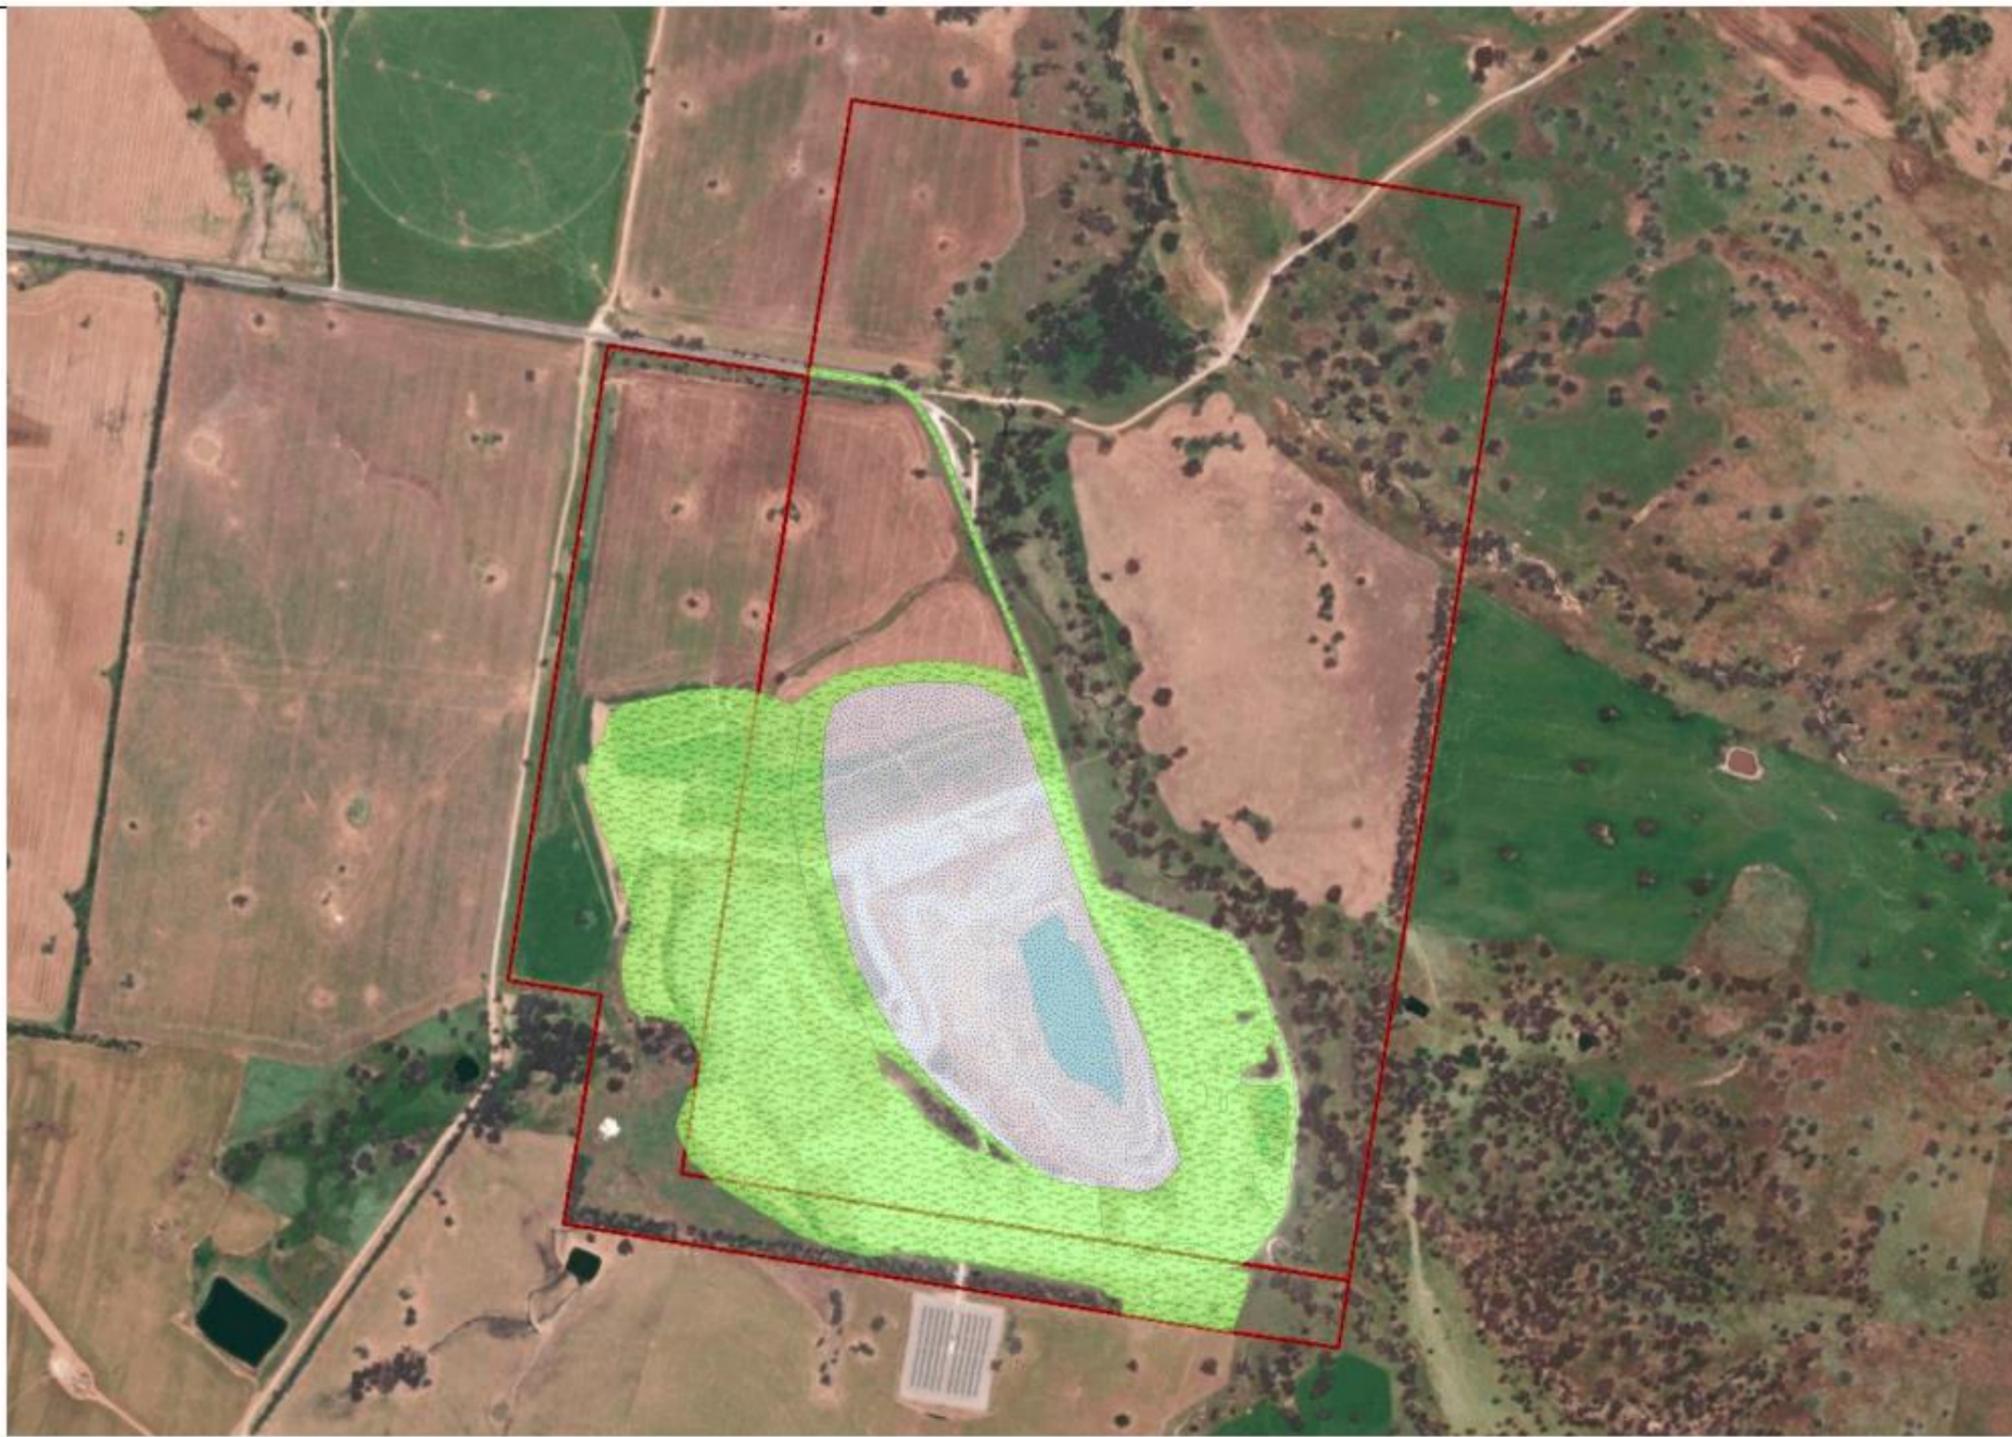
Figure 2 Final landform and rehabilitation plan - Final land use

Galong Limestone Mine, FLRP Plan 1A: Final Landuse, Year 2055, Sub.Id. 6703, 6078

Figures Figure 2 to Figure 5 provide an electronic copy of the approved final landform and rehabilitation plans.

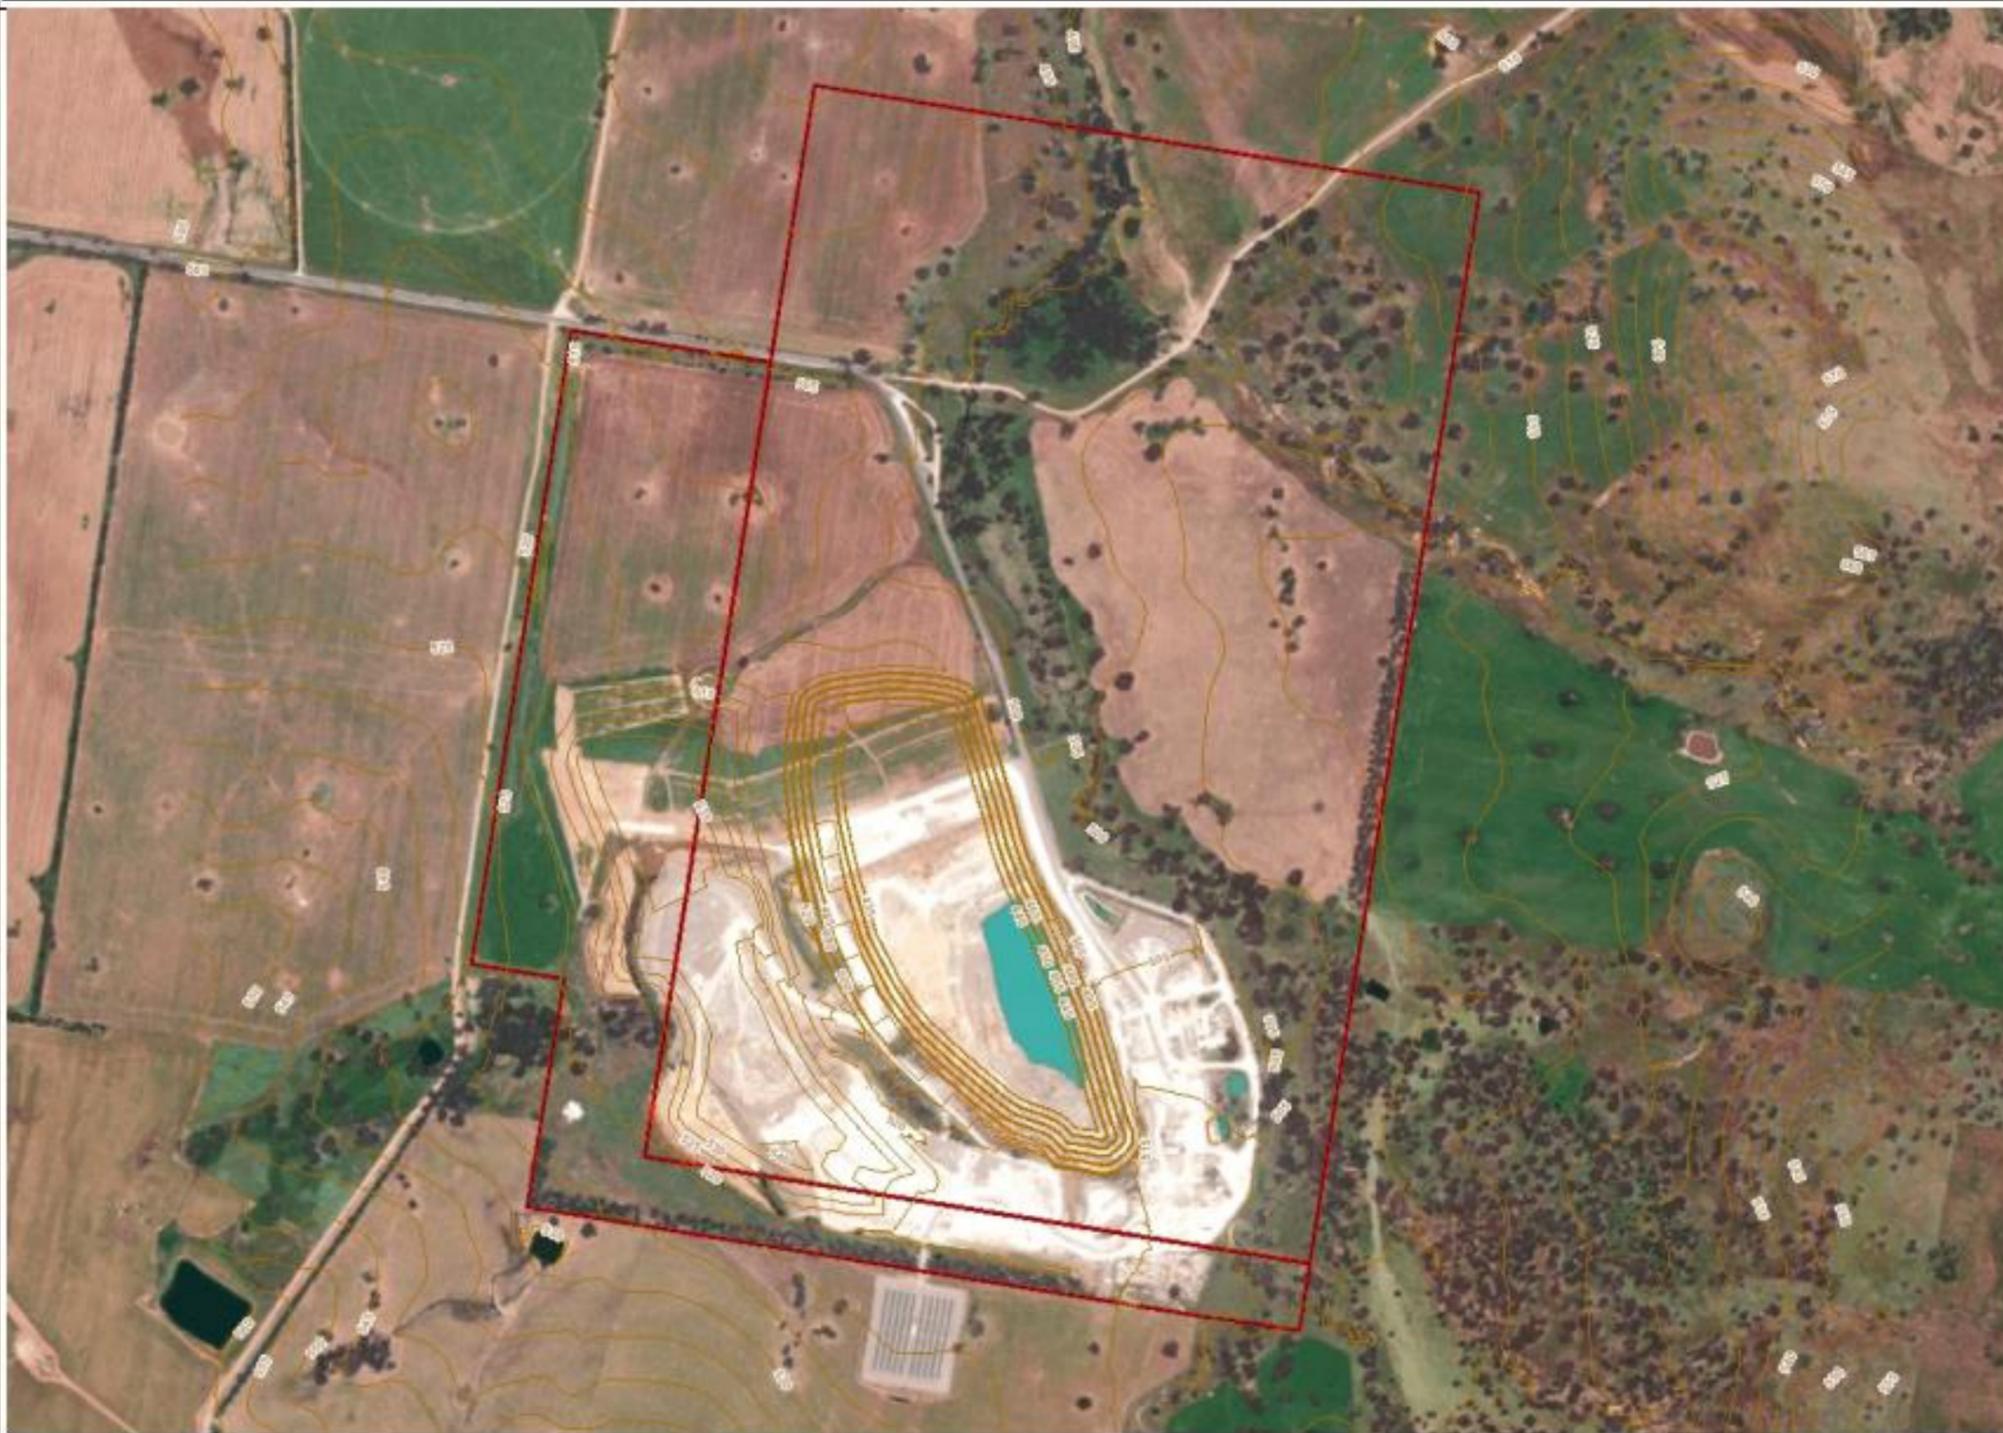
Figure 5 Final landform and rehabilitation plan - Final landform contours

Galong Limestone Mine, FLRP Plan 2A: Final Landform Contours, Year 2055, Sub.Id. 6703, 6077

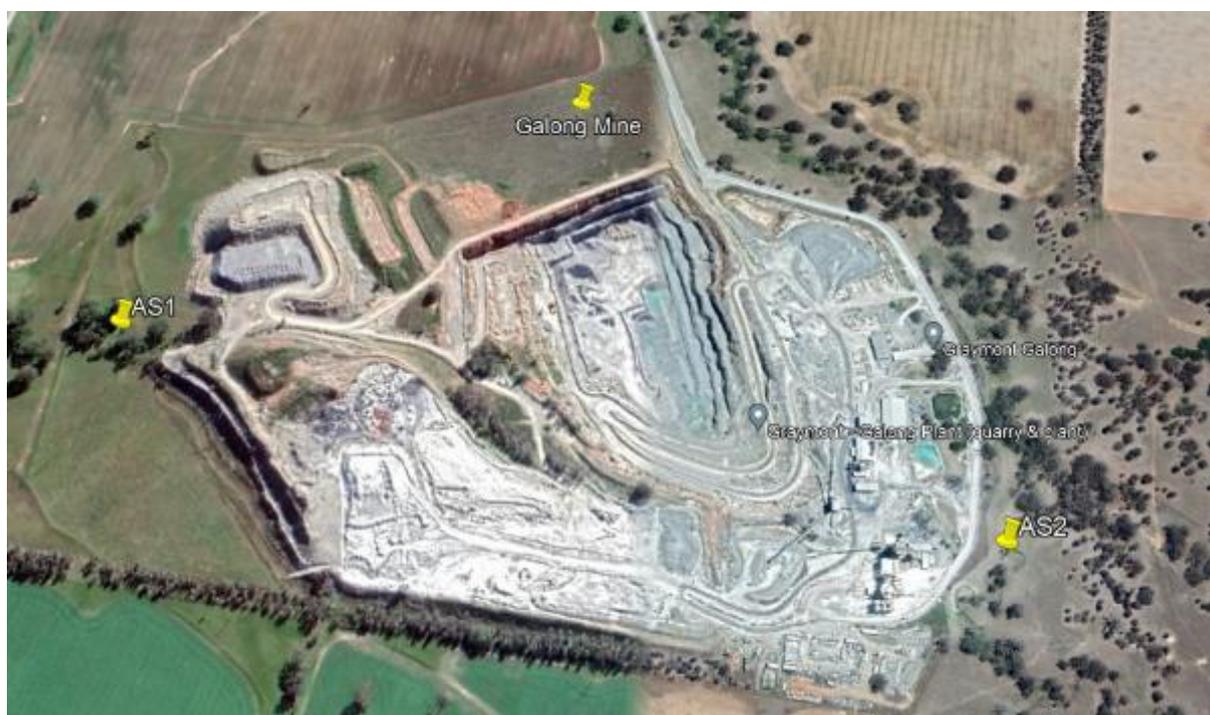
Figure 13: Analogue sites

Figure 13 shows the tow analogue sites.
